# Inspection Report

TEST 2016-12-5 Inspection of Bldg AAA (Clubhouse)

Big Property Management Company

Garden Community - 001

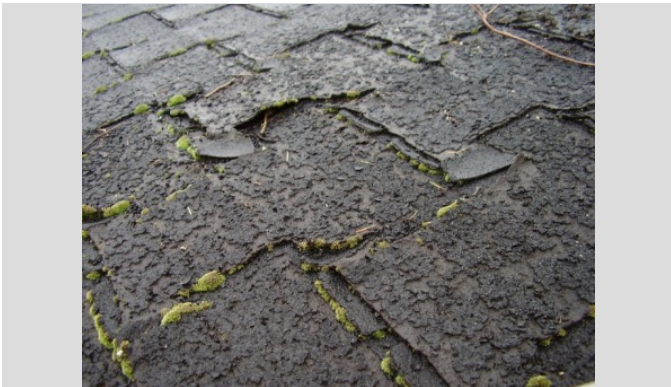
#### Sector Main Roof - 01

**Blistering (no rupture)**

2/2/2017 photo of Blistering (no rupture)

*Remove affected shingles. Re-install fresh shingles. If in a highly-visible area, re-do entire sector.*

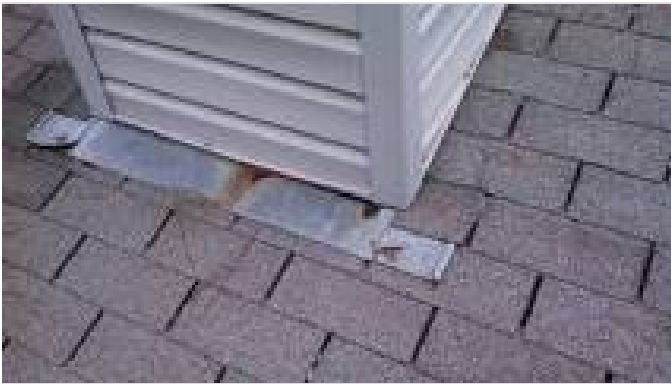
### Sector Main Roof - 01

#### Deteriorated Strip Flashings

2/2/2017 photo of Deteriorated Strip Flashings

Remove deteriorated flashing. Scrape and dry surface. Prime surface. Reapply fresh adhesive and let set for two minutes. Apply new flashing.

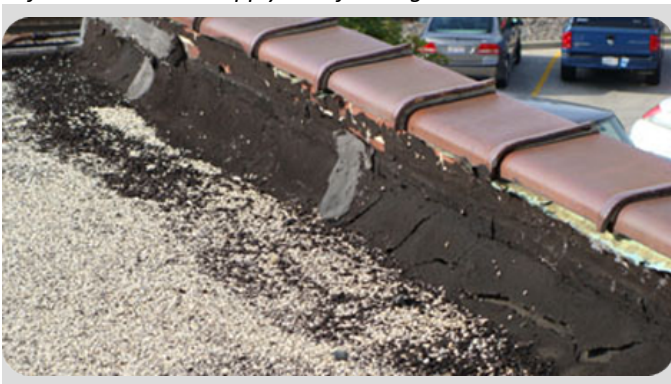
### Sector Main Roof - 02

#### Deteriorated Base Flashings

2/2/2017 photo of Deteriorated Base Flashings

Remove deteriorated flashing. Scrape and dry surface. Prime surface. Reapply fresh adhesive and let set for two minutes. Apply new flashing.

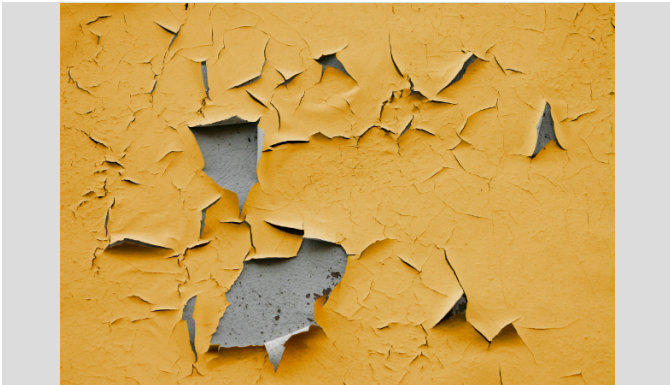
### Sector Northeast Wall - NEWall

The paint on all four walls of the Clubhouse is almost completely gone. The whole structure needs to have remaining existing paint scraped. Then it should be thoroughly pressure-washed. Finally, two coats of a quality exterior grade paint should be applied. Failure to take immediate action on this will result in water intrusion that will cause irreparable structural damage.

#### Peeling Paint

2/2/2017 photo of Peeling Paint

Strip area at least three feet beyond observed peeling. Re-paint with matching color. Repaint entire wall if in highly-visible area.

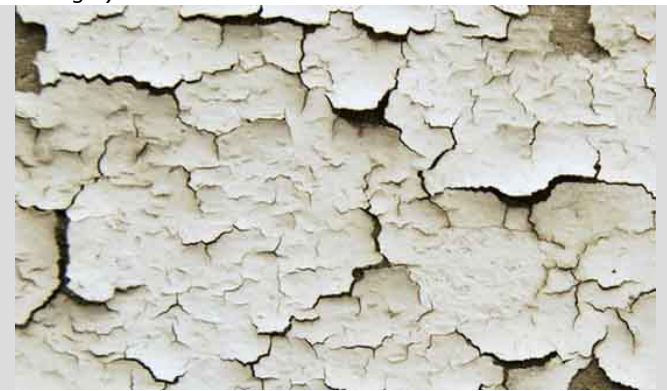
### Sector Northwest Wall - NWWall

#### Peeling Paint

2/2/2017 photo of Peeling Paint

Strip area at least three feet beyond observed peeling. Re-paint with matching color. Repaint entire wall if in highly-visible area.

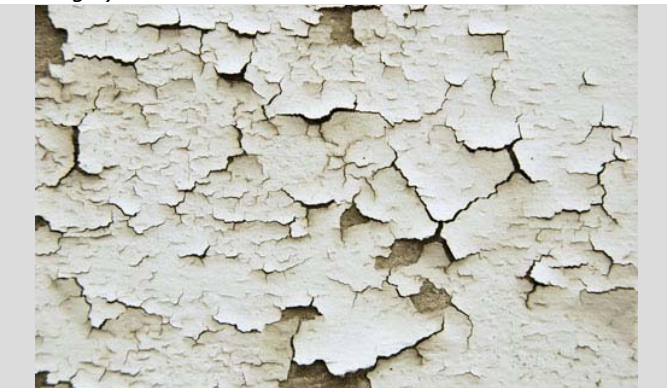
### Sector Southeast Wall - SEWall

#### Peeling Paint

2/2/2017 photo of Peeling Paint

Strip area at least three feet beyond observed peeling. Re-paint with matching color. Repaint entire wall if in highly-visible area.

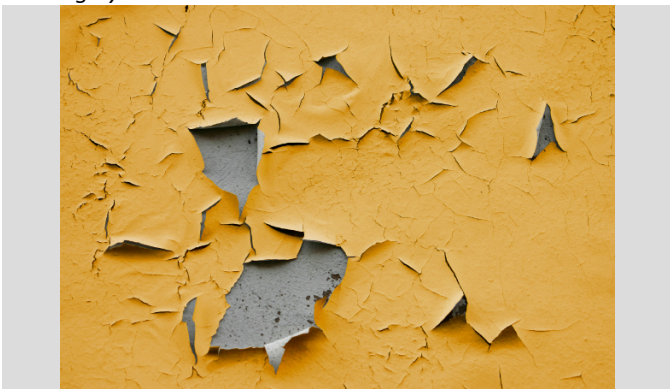
### Sector Southwest Wall - SWWall

#### Peeling Paint

2/2/2017 photo of Peeling Paint

Strip area at least three feet beyond observed peeling. Re-paint with matching color. Repaint entire wall if in highly-visible area.
